## Misalignment Tool Installation Process

This document references an installation of the WSI misalignment tool in the Eagle Ford shale play. The customer has multiple units out of alignment. This was the first installation for the customer on a well that was approximately 3.5 degrees out of alignment causing premature wear on production tree components. The WSI misalignment tool, which provides customers up to 5 degrees correction in any direction, allowed a correction on this well that aligned all components above the tool to level. Below are pictures of the installation and the correction in alignment.

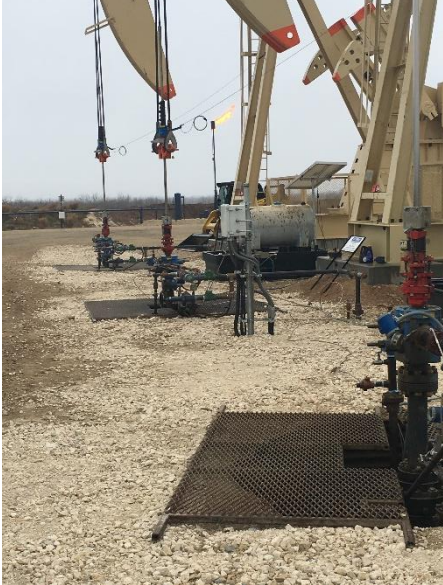
| <p>Three well pad for customer in Eagle Ford.</p> <p><b>Well depth:</b> 5600' vertical, 2000' lateral<br/>SPM: 5</p> <p><b>Packing Used:</b> Soft</p> <p><b>Packing Life:</b> 2 months before installing Misalignment tool</p> <p><b>Polished Rod Lubricator:</b> Yes</p> <p><b>Rod Rotator:</b> 4033 Pro-Torque Slow Gear</p> <p><b>Leveling Plate:</b> Yes</p> | |

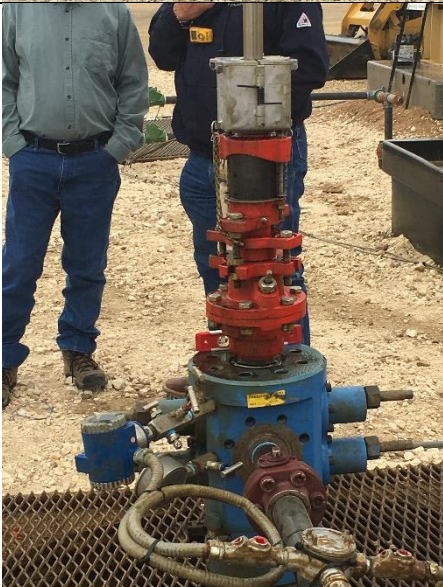
| <p>WSI Hookup:</p> <ul style="list-style-type: none"> <li>• 5K Dual Ram BOP</li> <li>• Classic DPSB w/ ECSS shutdown switch</li> <li>• Polished Rod Lubricator</li> <li>• 10T Polished Rod Clamp</li> <li>• Leveling Plate</li> <li>• 4033 Pro-Torque Rod Rotator</li> </ul> | |

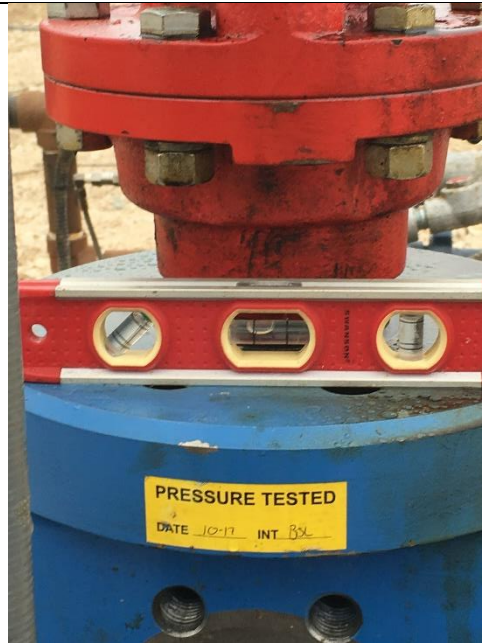
Unit is approximately 3.5 degrees out of alignment left of unit, without the misalignment tool
